**Kauai Museum** proposed roof repairs to the Wilcox building, property address 4428 Rice Street, Tax Map Key: (4) 3-6-005:005, Lihue, Hawaii.

**Subject:** **Kaua'i Museum – Wilcox Building – Roof Replacement**

Attachment A  
 Kaua'i Museum – Wilcox Building – Roof Replacement

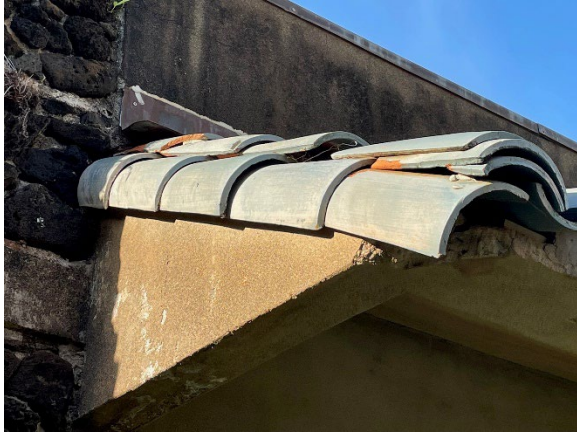
Rake Detail

- Photos clearly show that the roof style is a Mission Style barrel tile roof;
- The material is glazed terra cotta, examples of which exist on historic buildings of the era throughout Hawaiʻi;

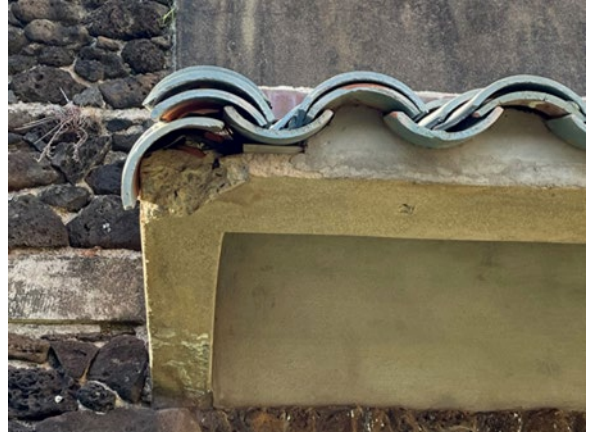
Eave Edge showing individual barrel tiles

Barrel tiles come in different lengths and can be either straight or tapered, all of which will affect the end result, as will the detailing at the ridge and edges.

As a starting point a qualified roofing contractor should remove an intact whole tile from an inconspicuous portion of the roof to verify size, shape and dimensions of the barrel tile. The length of the exposed face of the tile course is also an important characteristic. It is likely that the tiles are installed with a copper wire holding each tile in place, in the traditional manner. While the traditional installation technique is the preferred method, contemporary codes and concern for stability in high winds may require that the tiles be installed with additional strength or stability. If that is the case, care should be taken to ensure any adhesives or fasteners are not visible from the exterior views.
